# Executive Summary

Despite the good results produced across the county, the public raised significant concerns about I-5 in Marysville resulting from the increasing number of crashes and the large number of crossover collisions. As a result, WSDOT conducted a comprehensive review of traffic safety on I-5 through Marysville.

The purpose of this study is to examine the collisions that went through cable median barrier on I-5 in Marysville, so we include the five vehicles that crossed through cable median barrier in 2005, making a total of eighteen through cable barrier incidents examined in this report. However, most other 2005 collision and traffic data is not yet available. As a result, some parts of this report must rely on data from 1999 through 2004.

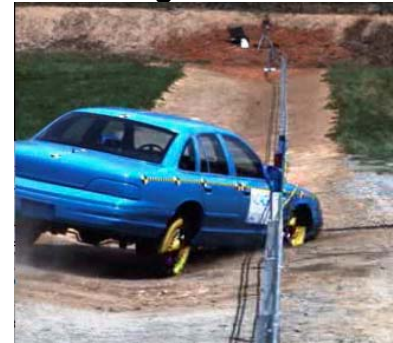
**Exhibit 0-1**  
**Car Lifting Cable Barrier**

*This photo, from a 2004 Federal Highway Administration crash test, shows how the front tires of a sedan compress after hitting the bottom of a ditch. This allows the bumper of the car to nudge under the lowest barrier cable.*

This data along with accident and maintenance reports, overwhelmingly suggest that southbound sedans ran into the median and bottomed out in the ditch. This compressed the cars' front tires, which left their front bumpers low enough to nudge beneath the lowest cable on the barrier. Then as momentum carried the cars up the slope, they lifted the cable median barrier and continued across the median as the cables passed over the top of the vehicle. This accounts for a preponderance of the cross-median collisions near Marysville.

In 2006, WSDOT will install a second run of cable barrier in the I-5 median in Marysville. We believe that placing barrier on both sides of the median ditch will address vehicles bottoming out in the ditch and lifting the cable barrier. Design is underway and we expect to install the new barrier in 2006.

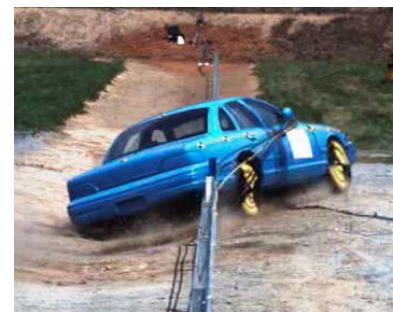
*As the vehicle continues forward it lifts the cable median barrier and continues up the slope, while the cables pass over the top of the vehicle.*

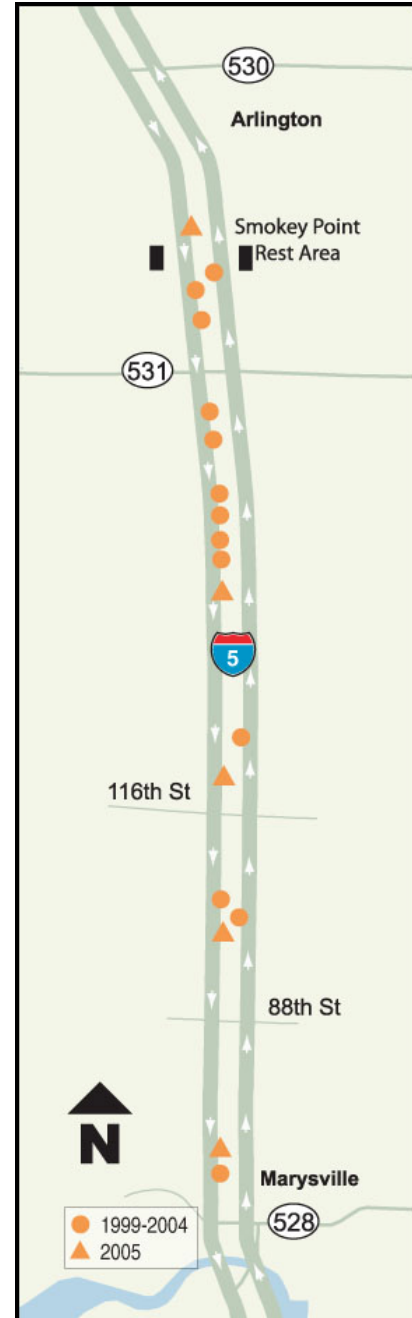
**Exhibit 0-2**  
**I-5 Marysville Cross**  
**Median Crashes**

Our research revealed that 15 of 18 (83%) vehicles that crossed the median on I-5 in Marysville from 1999 through 2005 were traveling in the southbound direction. This was even more notable because southbound vehicles in this area comprised only 46 percent of all cable rail collisions between 1999 through 2004. All three crossover collisions that resulted in fatalities involved southbound vehicles. This led us to focus our research on southbound crossover collisions.

We then examined the locations where southbound sedans crossed the median. We found that these crossover collisions occurred where the cable barrier was placed within five feet of the bottom of the ditch on the slope nearest the northbound lanes, that is, on the opposite side of the ditch from the southbound lanes.
